Energy Design Update[®]

Vol. 22, No. 12

December 2004

“Whole-Duct-System” R-Values

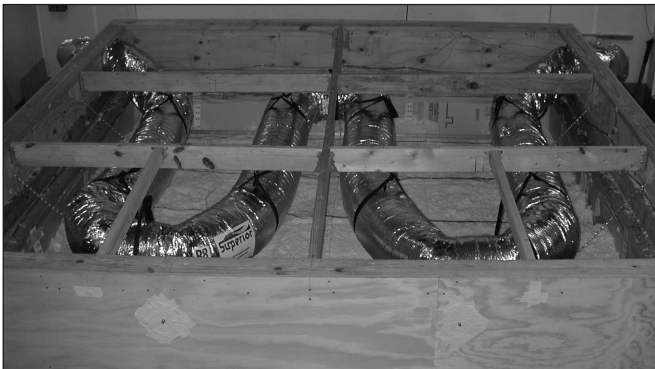
Figure 2. ORNL’s testing lab includes a “simulated attic” installed in a large-scale climate simulator (see the “News Briefs” section of *EDU*, July 2004). The apparatus was recently used to test the performance of three types of flex duct.

Research engineer Tom Petrie conducted the testing in ORNL’s large-scale climate simulator. The test compared the performance of three 10-inch-diameter duct systems, each about 34 feet long, installed in a test box simulating an unventilated attic with an insulated floor. The flex duct was hung from truss-like framing and arranged in a serpentine configuration (see Figure 2).

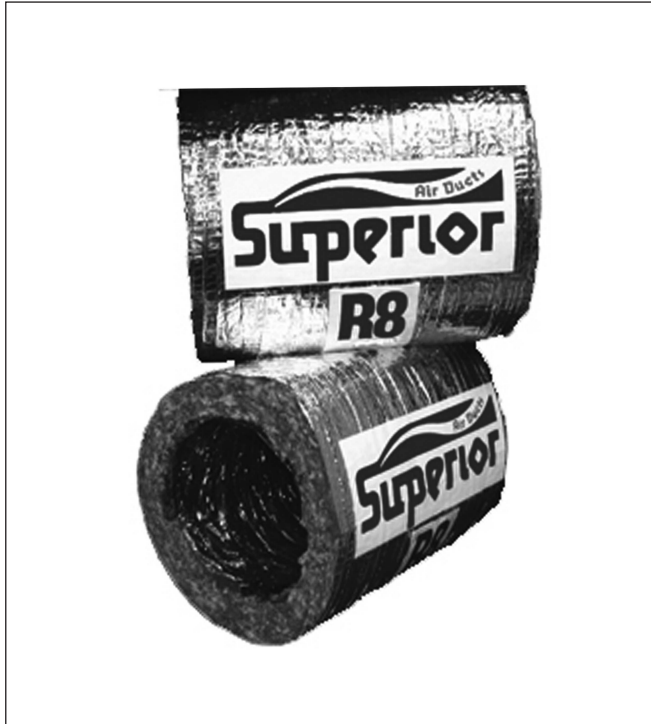
Figure 3. Superior Air Duct is a “semi-flex” duct insulated with 100% cotton insulation.

Marketing materials from Payless Insulation describes R-8 Superior Air Ducts as “semi-flex” ducts. The ducts incorporate insulation made from 100% cotton wrapped with a reflective Mylar jacket (see Figure 3). Superior Air Ducts are available in diameters ranging from 2 inches to 20 inches, in three different lengths (10, 15, or 25 feet). The list price is \$2.82 per linear foot for the 6-inch-diameter duct and \$4.04 per linear foot for 10-inch-diameter duct — about two or three times the price of fiberglass-insulated flex duct.
